# FINAL REPORT

## Infrared Reflectance Imaging for Environmentally Friendly Corrosion Inspection Through Organic Coatings

ESTCP Project WP-0407

MAY 2008

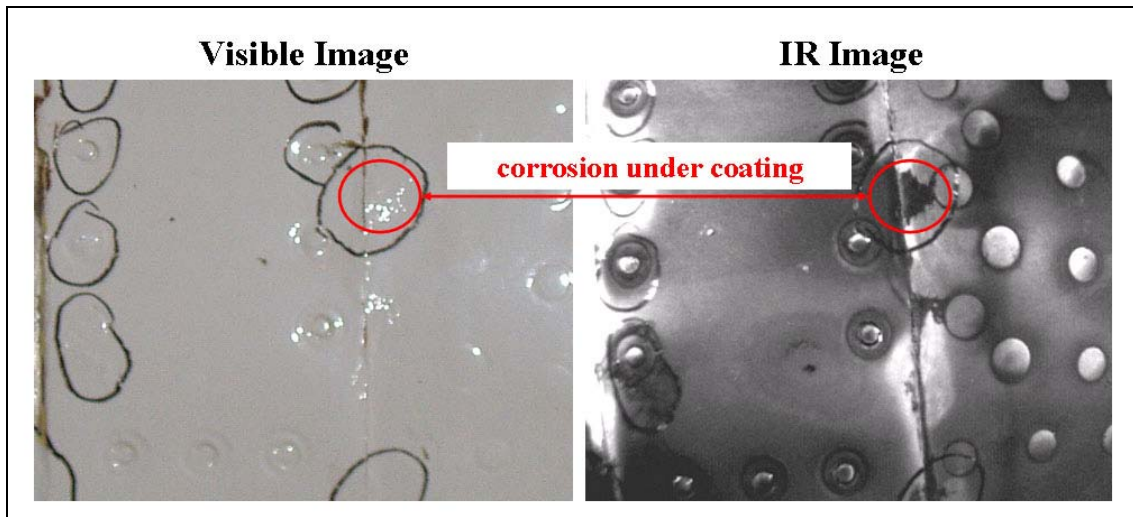
There is a significant reduction in reflectance from a corroded substrate. By identifying the ratio of the reflectance spectra of the painted clean aluminum to the spectra of the painted corroded aluminum, a contrast enhancement technique was developed. It was found that the corrosion signature in the paint transmission window can be "seen" through this paint system with this camera. Figure 2-3 illustrates an IR image with corrosion beneath the coating, note the corrosion and how it appears dark.

**Figure 2-3: Visible Image versus IR Image**

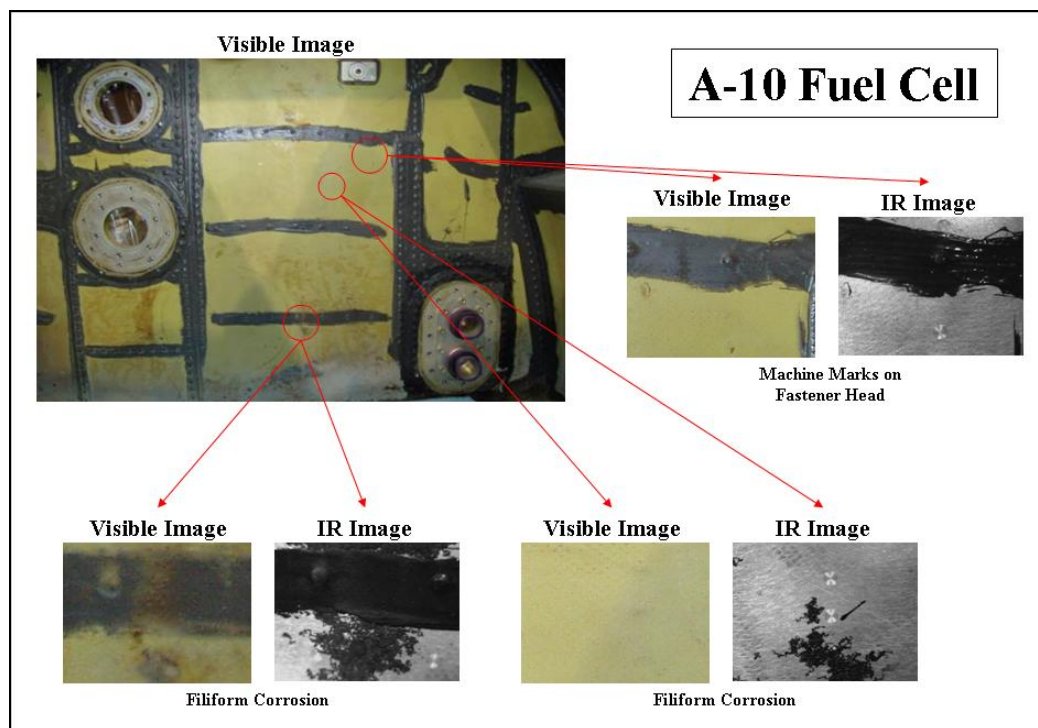
**Figure 3-3: A-10 Fuel Cell - IR Images**

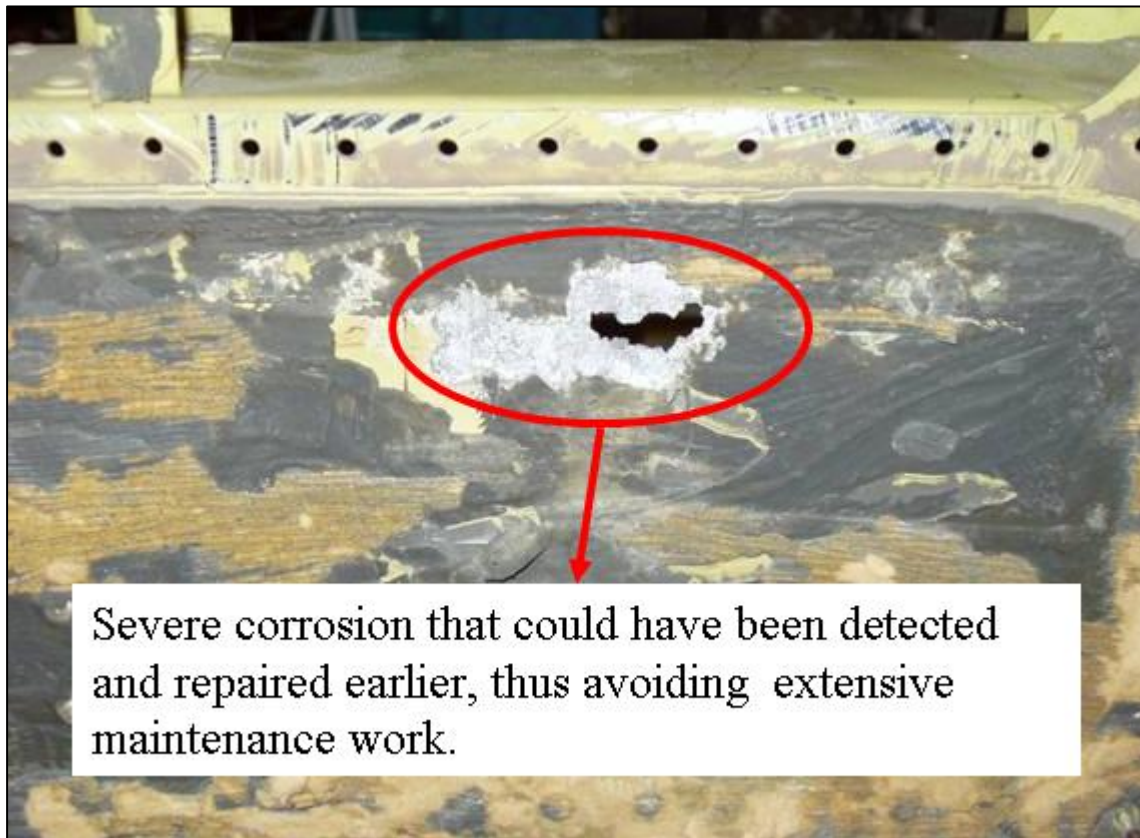
A mini-demonstration was held at Hill Air Force Base (HAFB) in Ogden, UT in March 2005 utilizing the IRRIT. It was shown with this demonstration that corrosion could be detected in areas not readily observable without the aid of this IR inspection tool. Current practice was to visually inspect the coatings for indications of corrosion, prior to rework of the corrosion. It was demonstrated that HAFB had the potential to visually “miss” corrosion not readily observable on the surface of the coating, and in fact this was the case. IR photographs that were taken clearly demonstrated that corrosion was visible under the coating and not on the surface (refer to Figure 3-3). If not properly maintained in a timely manner this would result in additional corrosion and more pollution (refer to Figure 3-4).

**Figure 3-4: Severe Corrosion in A-10 Fuel Cell IML**

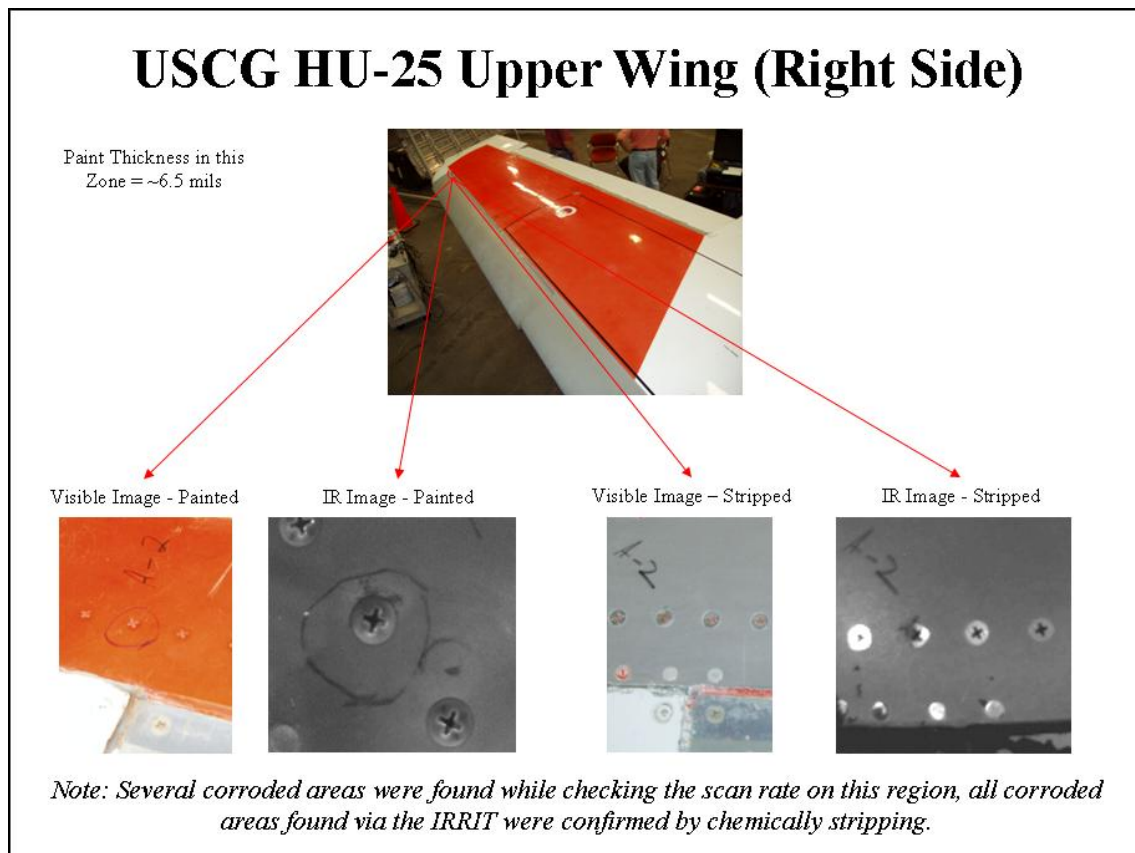
The IRRIT demonstrated the ability to detect corrosion under the HU-25 paint scheme of cross section thickness between 8-10 mils. This was successful, despite the relatively thick coatings and glossy paint scheme of the aircraft. The camera was easy to use, lightweight, and demonstrated enhanced capability as compared to visual inspection and flash thermography.

**Figure 3-5: USCG HU-25 - IR Images**

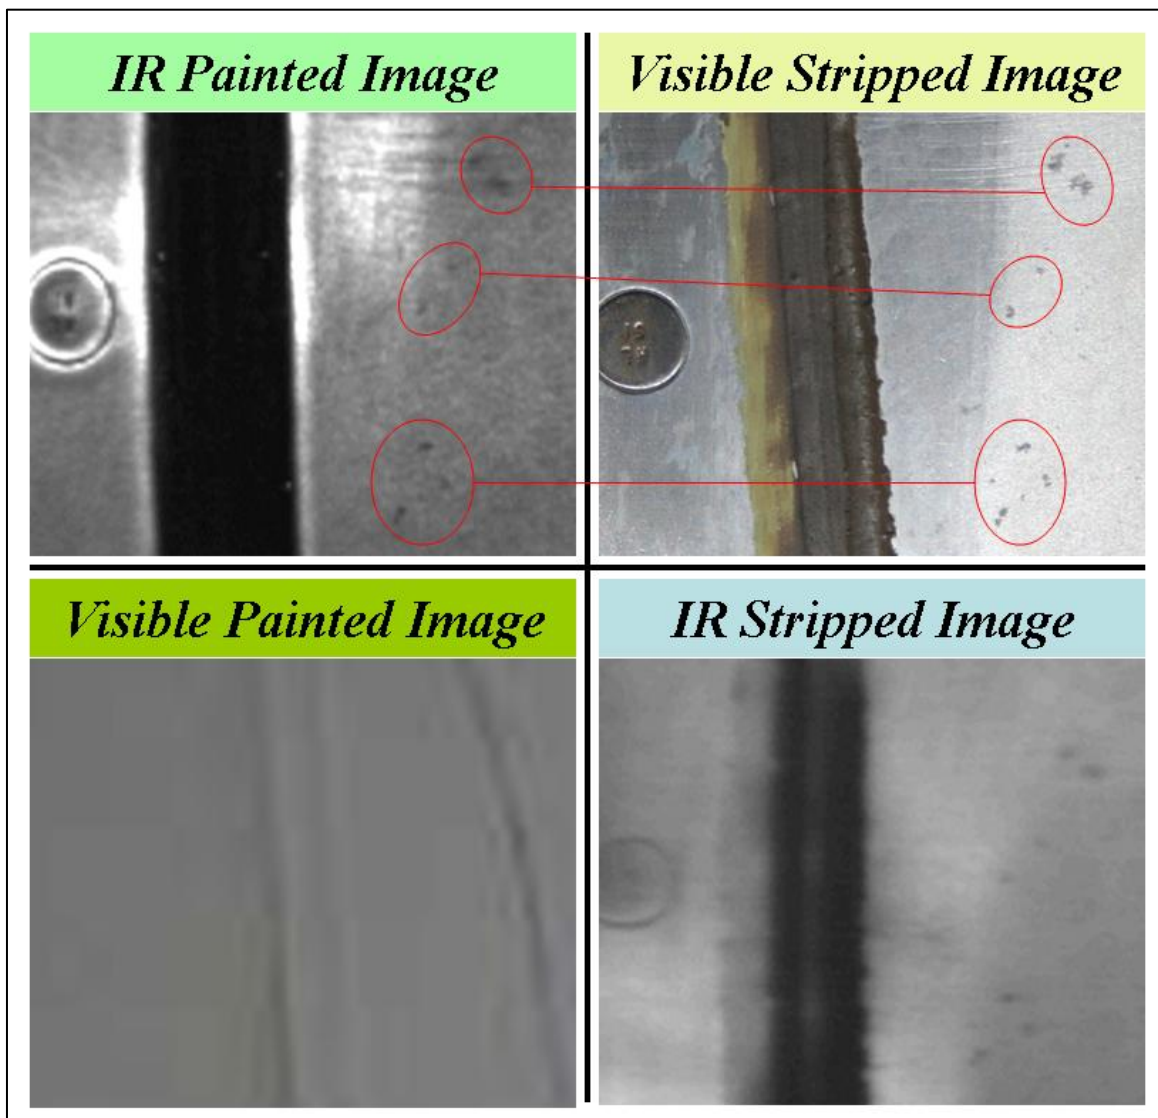
**Figure 4-1: P-3 Tail #912 (Wing Section) - IR Image**

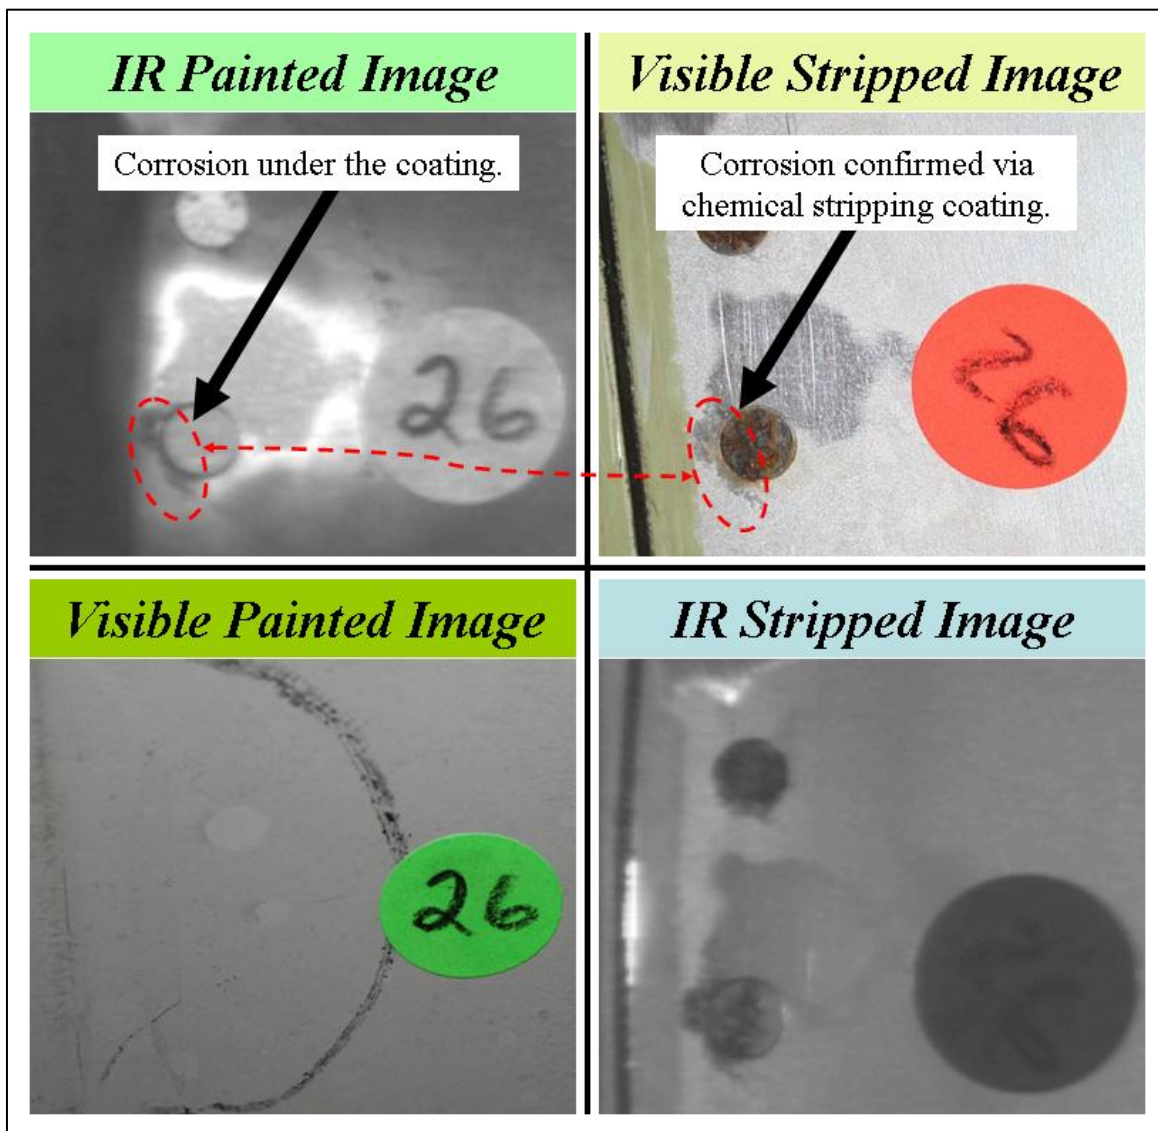
Figure 4-3: P-3 Tail #772 (Wing Section) - IR Image

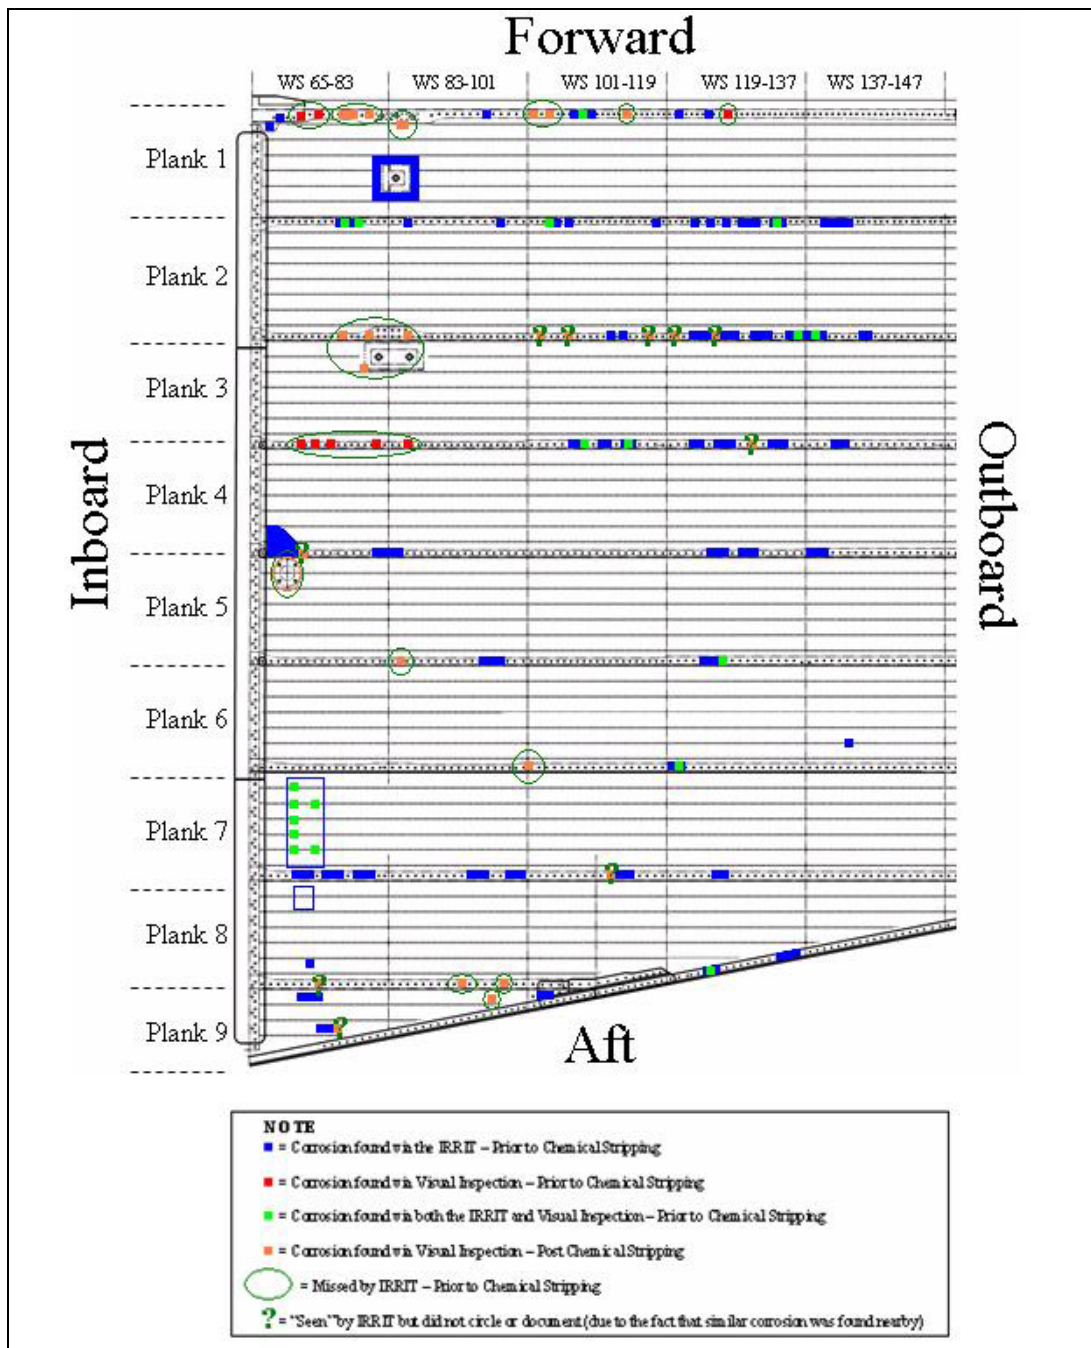
Figure 4-4 illustrates the corrosion locations that were identified during the Navy P-3 (Tail #772, BUNO 162772) Dem/Val. The note within the figure defines the corrosion location and what method they were found and documented.

Figure 4-4: Navy P-3 OML Wing Section Corrosion Location Identification

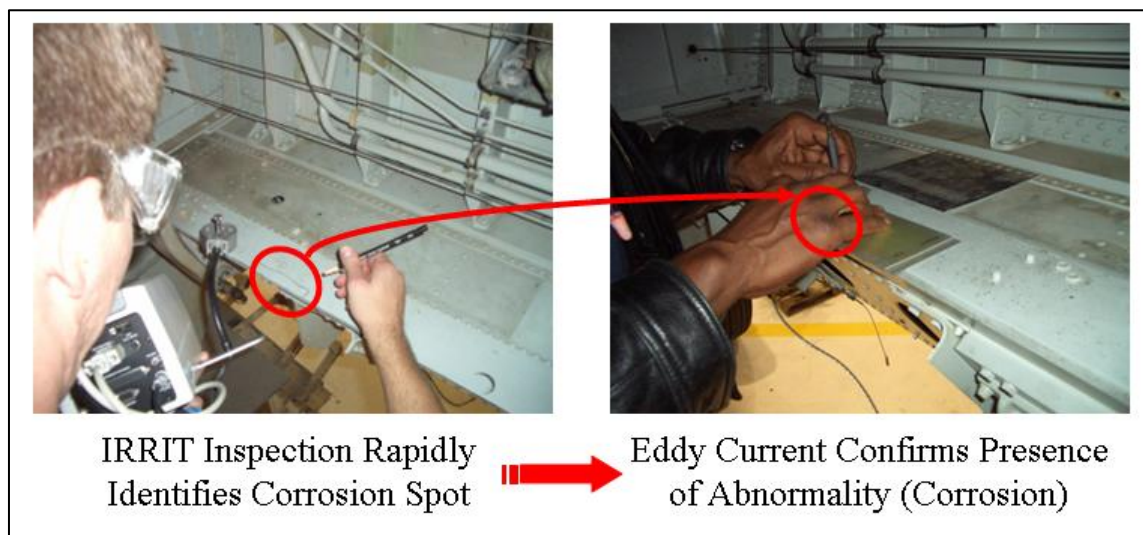
The IRRIT inspection process performed acceptably on the B-52 IML with no significant inspection performance impacts due to complex geometry (found in KC-135 IML). Based on the IML Dem/Val results, future IRRIT inspections will require the removal (dry-wiping) of surface contamination, known to be problematic in IR (i.e., dirt, dust, oil, grease, etc.), prior to inspection (refer to Figure 4-7). Early detection of corrosion allows the user to minimize or prevent structural damage and pollution prevention through the use of the IRRIT (refer to Figure 3-4). IRRIT inspection process provides improved sensitivity for detection of surface corrosion as compared to standard eddy current and visual inspection methods utilized at OC-ALC (refer to Figure 4-6).

**Figure 4-6: IRRIT versus Eddy Current**

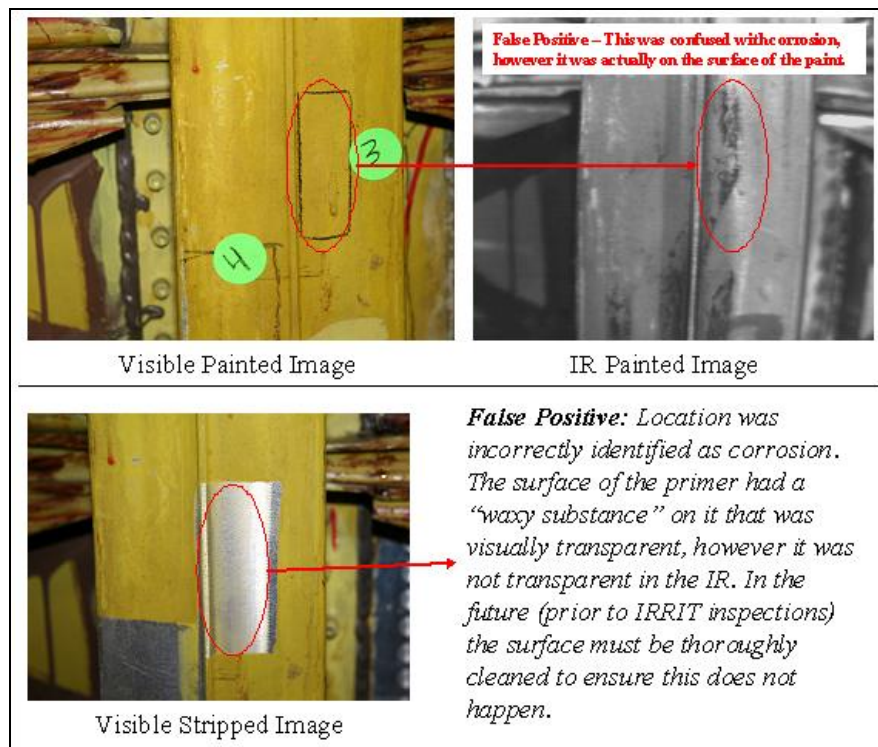
**Figure 4-7: False Positive – Location Incorrectly Identified as Corrosion by IRRIT**

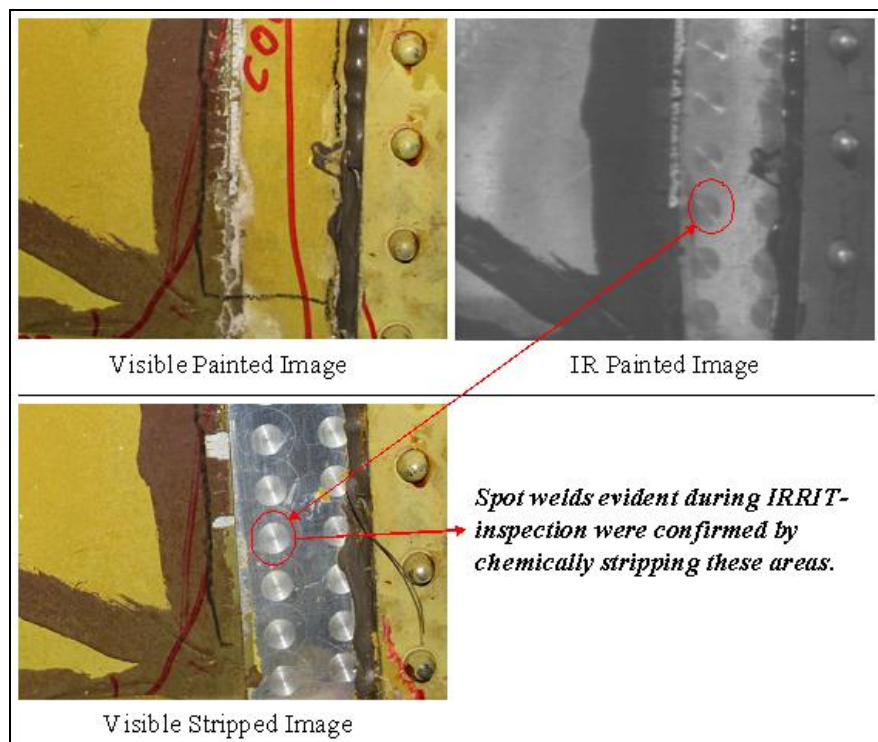
**Figure 4-8: Spot welds evident via IRRIT inspection**

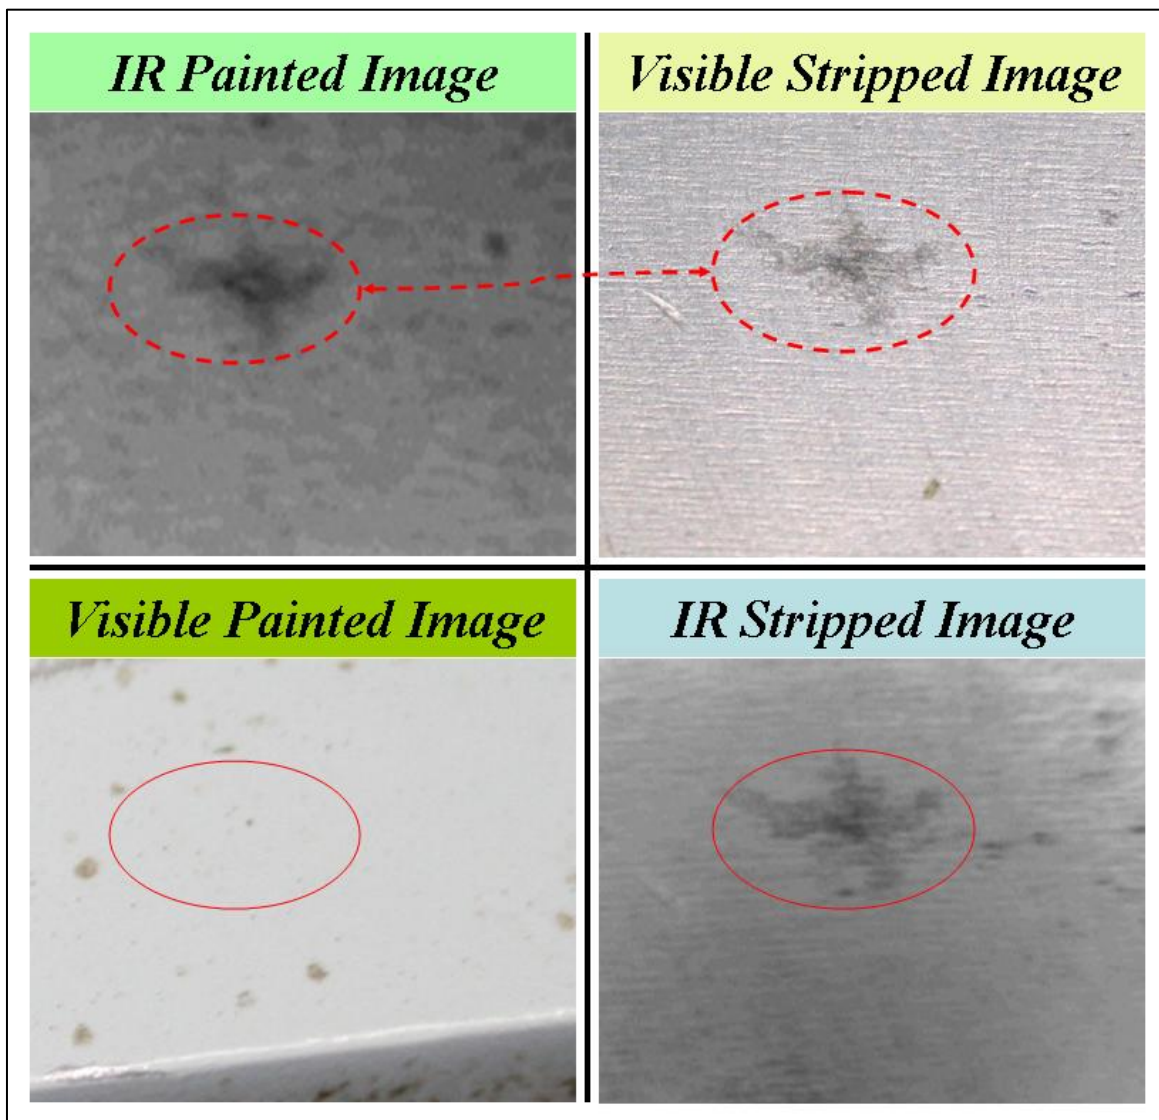
**Figure 4-9: B-52 #1 (Longeron Section) - IR Image**

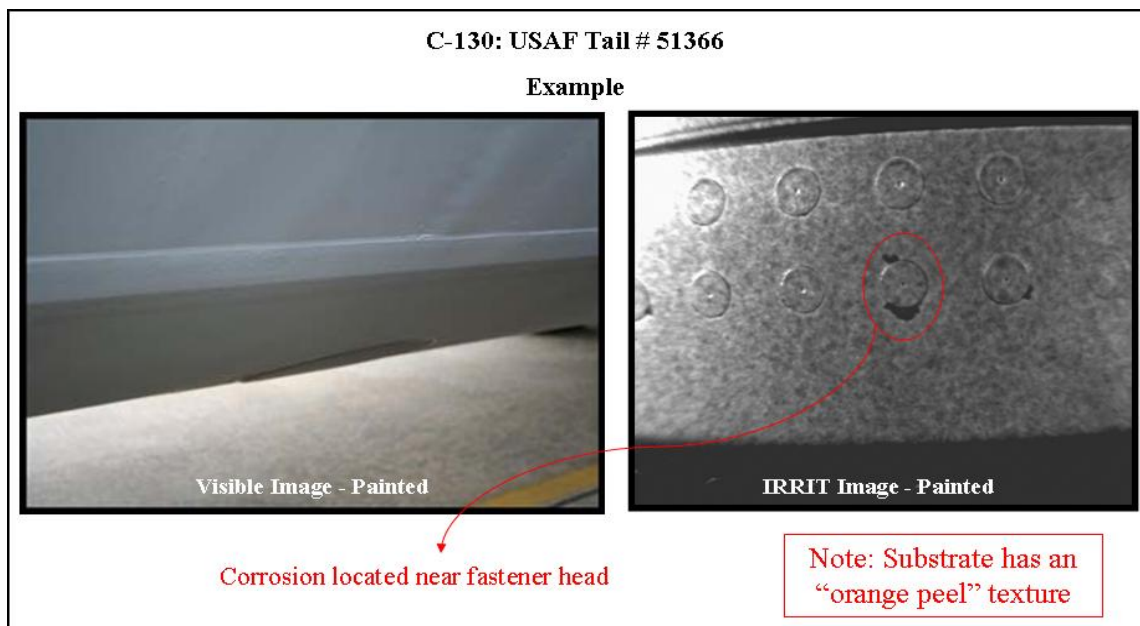
**Figure B-3: Corrosion Under OML Coating of C-130**

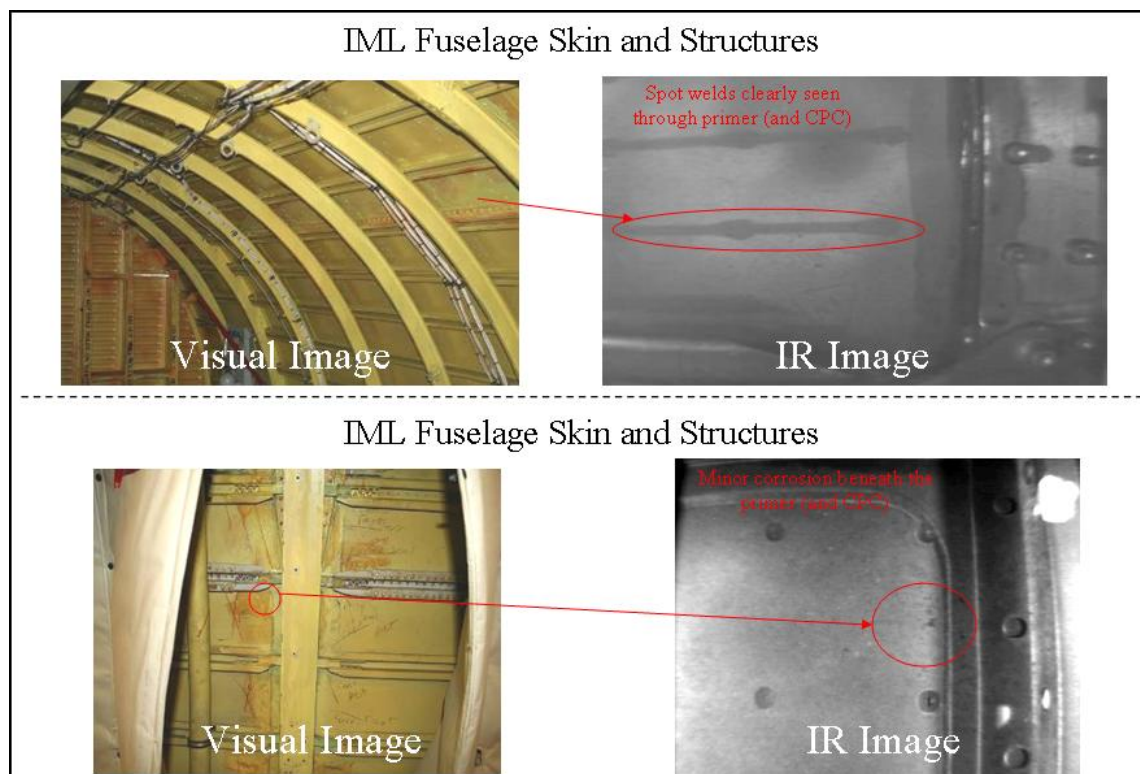
**Figure B-7: KC-135 IML Visual and IR Images**
